White paper: Technical-scientific informative ITC-01 / ATCP

Piezoelectric ceramics testing for crack detection

ATCP Physical Engineering
www.atcp-ndt.com

Revision 1.5
November 28th, 2022

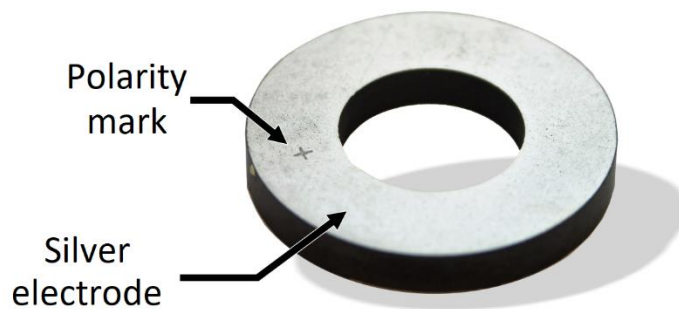
Figure 1 shows a typical piezoelectric ceramic of 20 kHz converters for ultrasonic welding. Its dimensions are 38.1 x 19.1 x 5.15 mm and its material the PZT-8. There are metallic electrodes on its two flat surfaces for the application of electrical voltage and one of the faces shows the polarity mark (the positive is marked with a "+" and/ or a dot "•", which may be also on the side). These ceramics are made by pressing and sintering doped powder of Lead Zirconate Titanate (PZT). PZT can be found under many denominations, confirm the correct application and specification with the manufacturer.

Pressed and sintered piezoelectric material.

Figure 1- Typical piezoelectric ceramic for ultrasonic welding converters.

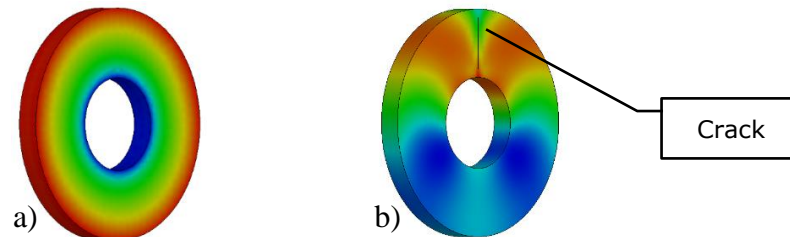
The presence of cracks on the piezoelectric ceramic breaks the stress symmetry causing stress concentration, leading to the growth of the crack in a vicious cycle and, eventually, to a complete rupture. Figure 2 shows the comparison between an intact ceramic ring deformation and a cracked ring, both in the fundamental radial vibration mode. Figure 3 presents an illustrative sequence of the growth of an internal crack until the rupture of the piece.

Figure 2 – Comparison between the deformation of an intact ceramic (a) in radial vibration mode and a cracked one (b)

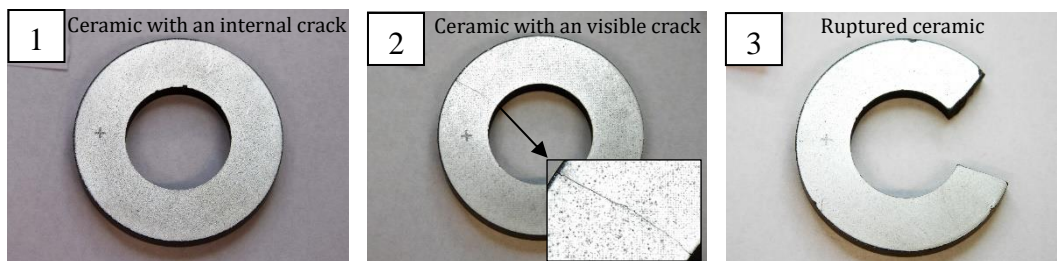
Figure 3 – Illustrative sequency of an internal crack evolution: 1^o) Ceramic with an internal crack, 2^o) Ceramic with a visible crack, 3^o) Fractured ceramic.

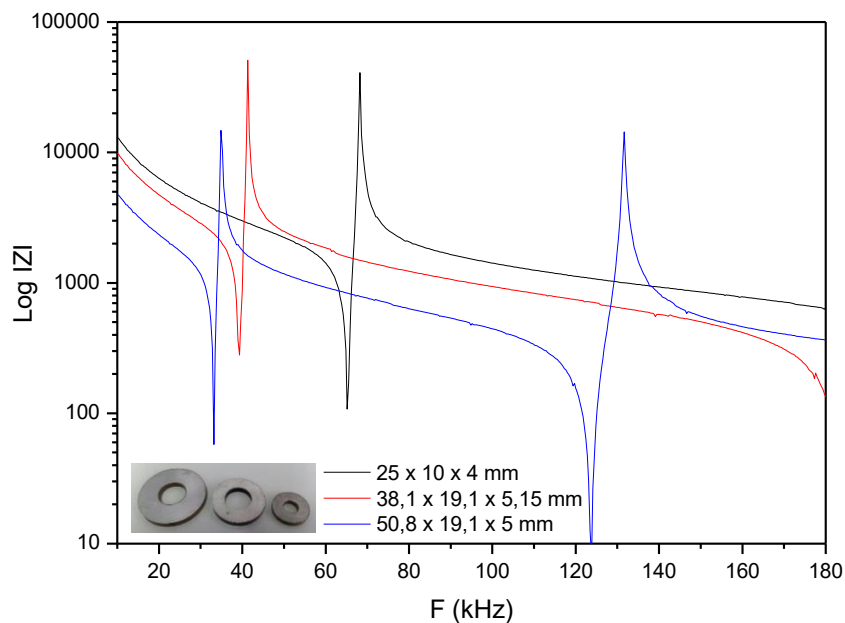
Figure 4 shows the typical impedance curve of three common and intact commercial piezoelectric ceramic pieces. Note that the bigger the ceramics, the lower are their frequencies. In the case of the bigger ring, measuring 50.8 x 19.1 x 5 mm, there is a second resonance that corresponds to a harmonic fundamental radial mode. Other commercial ceramics with similar dimensions shaped like rings present the same pattern.

Figure 4 – Typical curves of the impedance module as a function of frequency for three typical and intact ceramic of ultrasonic welding and cleaning converters.

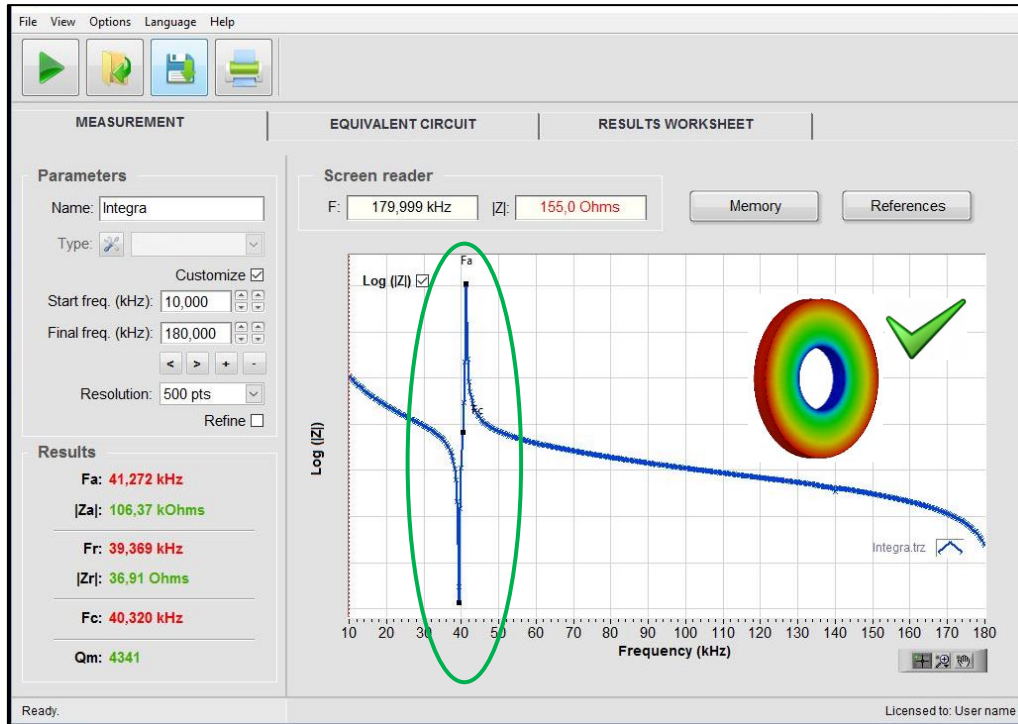
The presence of cracks allows the occurrence of additional vibration and resonance modes, which are detectable by employing the TRZ[®] Analyzer and Software. Figures 5 and 6 present the impedance spectroscopies (impedance module as a function of frequency/curve $|Z(f)|$) of two similar piezoelectric ceramics, being one of them intact (Fig. 5) and the other cracked (Fig. 6).

Judging the result is visual and straightforward: there must be no multiple resonances (from additional vibration modes allowed by the crack), and there must be a maximum of two vibration modes in the frequency range from 10 to 200 kHz for ceramics with the external diameter measuring between 15 and 100 mm. The intact ceramic (Fig. 5) presents only one vibration mode highlighted in blue, while the cracked ceramic (Fig. 6) presents several additional vibration modes, besides the main vibration mode.

Figure 5 – Example of the impedance curve for an intact piezoelectric ceramic ring (a PZT-8 ceramic with dimensions measuring $38.1 \times 19.1 \times 5.15$ mm).

Start the measurement by clicking on "Play" (Fig. 10) or using the shortcut command Ctrl-N. Then, check if the obtained curve is subtle or if it has disturbances of low amplitude (see Figures 5 and 6). If spurious modes are detected, the piezoelectric ceramic is cracked and must be discarded. The presence of cracks may be confirmed by non-destructive ultrasonic testing (pulse-echo).

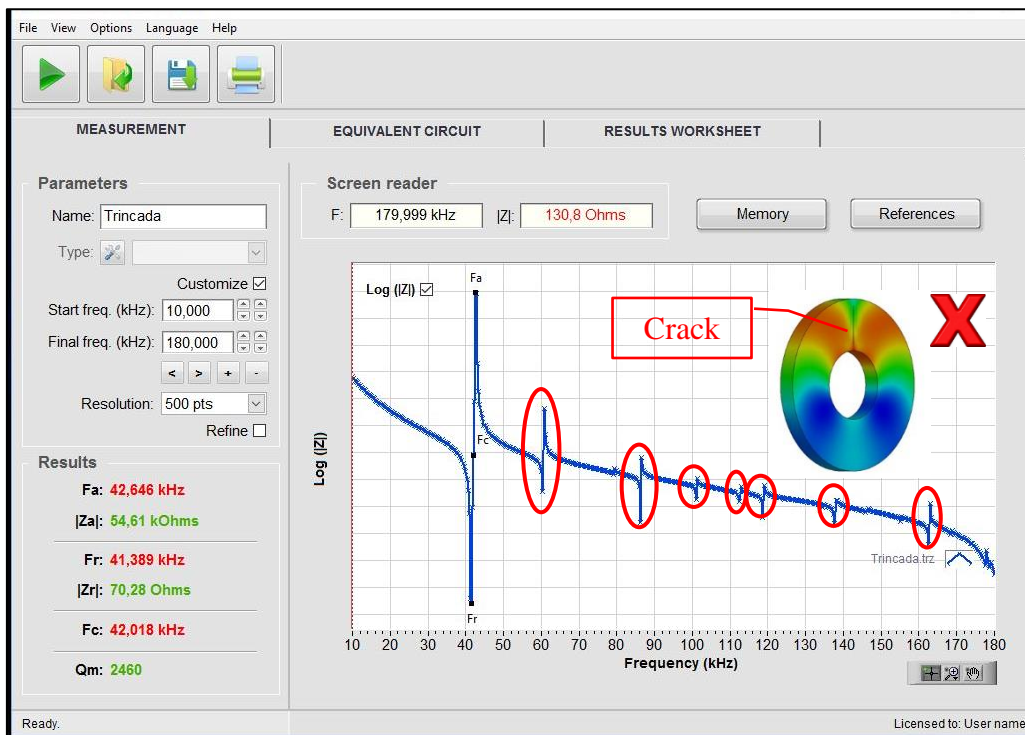
Figure 6 – Example of the impedance curve for a cracked piezoelectric ceramic ring (a PZT-8 ceramic with dimensions measuring $38.1 \times 19.1 \times 5.15$ mm).

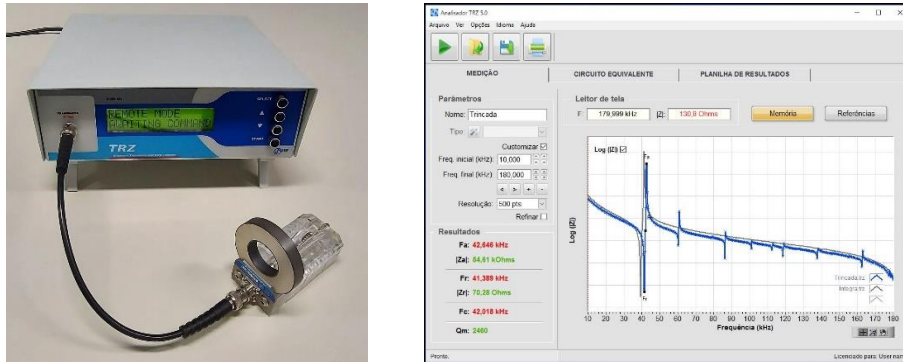
Use the TRZ® Analyzer along with the TRZ® Software (version 7.0 or superior) and the PiezoHolder support for ceramics (Fig. 7). Select the option “Piezos” from the Software (Fig. 8). Under this pre-configuration, the TRZ® Analyzer and Software will perform a sweep from 10 to 200 kHz.

Figure 7 – TRZ Analyzer connected to PiezoHolder and TRZ® Software.

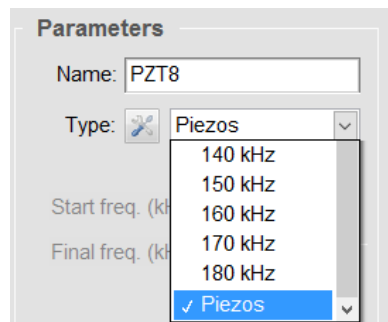
Figure 8 – Selection for testing ceramics (TRZ® Software, 7.0 or higher).

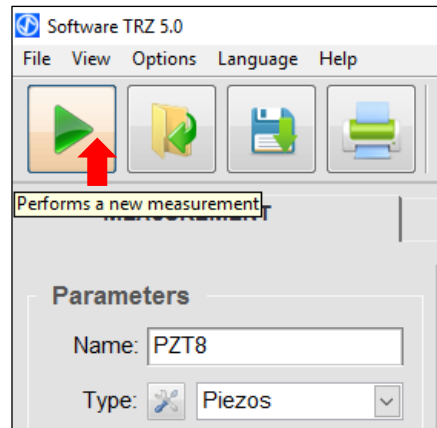
Figure 10 – Carrying out measurements.

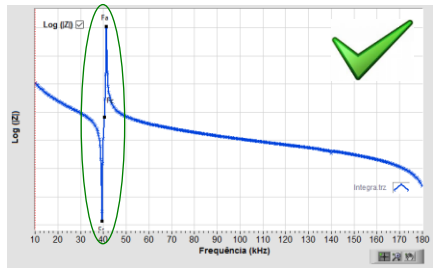
<p>This new ceramic was approved because there are no additional resonances and because of a well-defined main resonance. <i>Note: the ATCP Physical Engineering logo was inspired by the shape of this wave pattern.</i></p>
<p>New ceramic with internal crack</p>

Table 1 shows the characterization results of a new and intact ceramic, a new but internally cracked ceramic, a used and internally cracked ceramic, and finally of a new one presenting an unknown defect. Note that the pattern of additional resonances indicating the presence of crack varies.

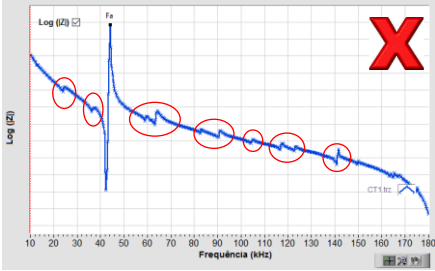
<p>This new ceramic was not approved because multiple additional resonances were detected. The existence of crack was confirmed by the non-destructive ultrasonic testing for the detection of discontinuities.</p>
<p>Used ceramic with internal crack</p>

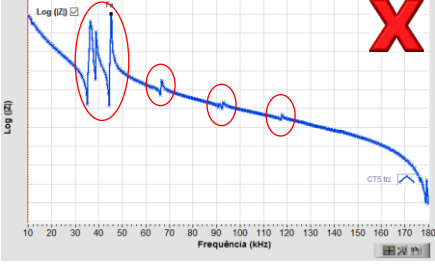
<p>This used ceramic was not approved because there are multiple additional resonances besides disturbances on the main resonance. The existence of crack was confirmed by the non-destructive ultrasonic testing for the detection of discontinuities.</p>
<p>New ceramic presenting an unknown defect</p>

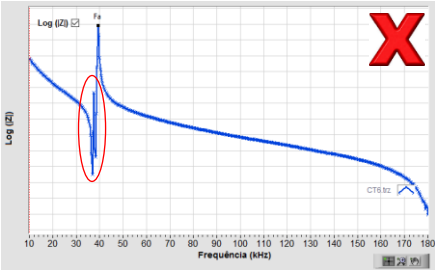
<p>This new ceramic was not approved because there is a disturbance on the main resonance, however it was not possible to confirm that it has an internal crack by non-destructive ultrasonic testing. The defect that generated this disturbance may be a density inhomogeneity of the pressed material.</p>

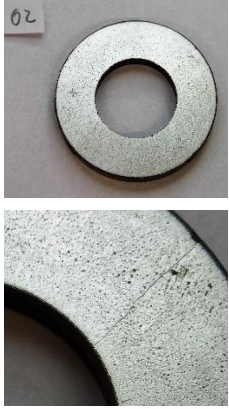
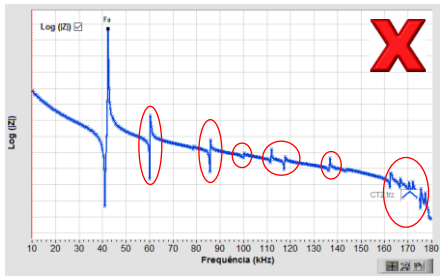
<p>This used ceramic was not approved because it shows a visible crack, besides multiple additional resonances.</p>
<p>Ruptured used ceramic missing a segment</p>

Table 2 shows detailed results of a used and visibly cracked ceramic characterization, and of a used and fractured one. These are extreme situations in which the visual inspections would have been enough to reprove and discard the pieces. The goal of presenting them here is only to enrich the exemplifications.

These cases present more accentuated additional resonances, but they are not too different from the additional resonances observed in internally cracked ceramics (refer to Table 1 curves).

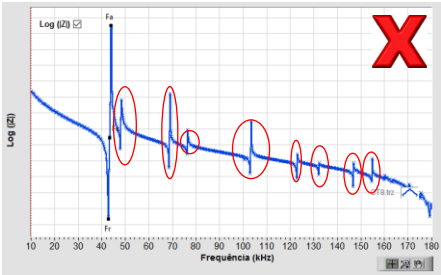
<p>The presentation of this test result (of a fractured ceramic missing a segment) aims to illustrate the application of the methodology in an extreme condition.</p>

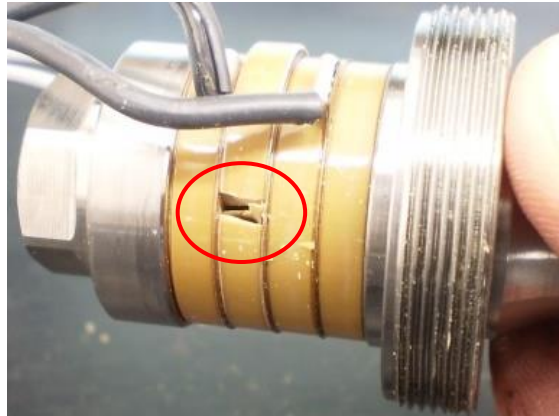
The fracture of ceramics is the main cause for faults for ultrasonic transducers and converters. Figure 11 exemplifies a 35 kHz damaged converter, highlighting the ruptured piezoelectric ceramic. However, not all ceramics of faulty transducers are necessarily cracked. On the contrary, some may be recovered to reduce maintenance costs, mainly when it comes to premature faults during manufacturing quality control. For that, it is necessary to use a methodology that guarantees the inexistence of cracks in the ceramics in order to safe reuse them.

Figure 11 – Ultrasonic converter with a fractured piezoelectric ceramic piece. The other pieces were recovered and used after being tested for internal cracks.
