White paper: Technical-scientific informative ITC-01 / ATCP

Piezoelectric ceramics test for crack detection

ATCP Physical Engineering
www.atcp-ndt.com

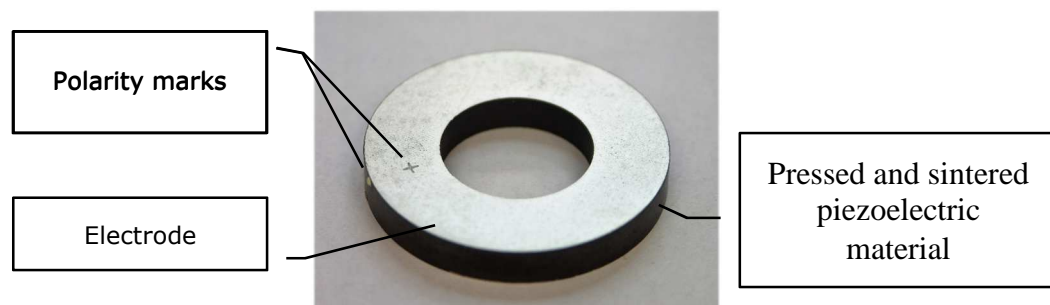
Figure 1 shows a typical piezoelectric ceramic of 20 kHz converters for ultrasonic welding. Its dimensions are 38.1 x 19.1 x 5.15 mm and its material is the PZT-8. There are metallic electrodes on its two flat faces for the application of electrical voltage and on one of the faces shows the polarity mark (the positive is marked with a "+" and/ or a dot "•", which may be also on the side). These ceramics are made by pressing and sintering the powder Lead Zirconate Titanate (PZT). PZT can be found under diverse variations and denominations, confirm the correct application and specification with the manufacturer.

Figure 1- Typical piezoelectric ceramic for ultrasonic welding converters.

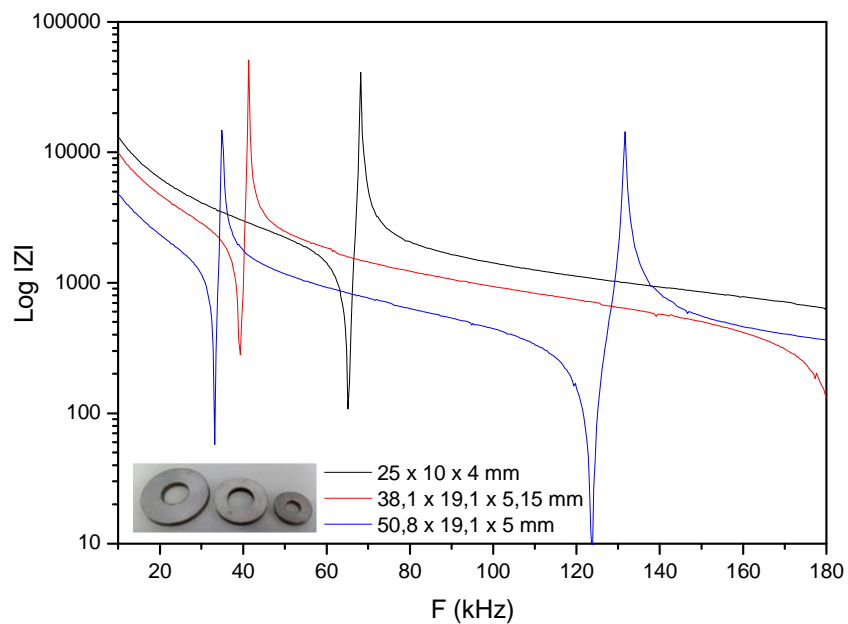
Figure 4 shows the typical impedance curve of three common and intact commercial piezoelectric ceramic pieces. Note that the bigger the ceramics, the lower are their frequencies. In the case of the bigger ring, measuring 50.8 x 19.1 x 5 mm, there is a second resonance that corresponds to a harmonic fundamental radial mode. Other commercial ceramics with similar dimensions shaped like rings present the same pattern.

Figure 4 – Typical curves of the impedance module as a function of frequency for three typical and intact ceramic pieces of ultrasonic welding and cleaning converters.

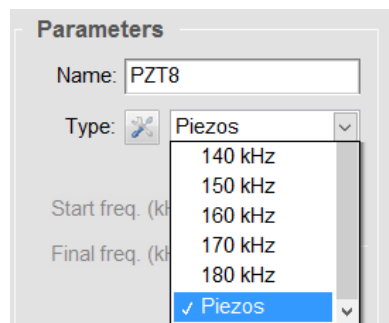
Figure 8 – Selection for testing the ceramics (TRZ Software, 5.0 or higher).

Use the TRZ Analyzer together with the TRZ Software (5.0 version or superior) and the PiezoHolder support for ceramics (Figure 7). Select the option “Piezos” from the Software (Figure 8). Under this pre-configuration, the TRZ analyzer and Software set will perform a sweep between 10 and 180 kHz.

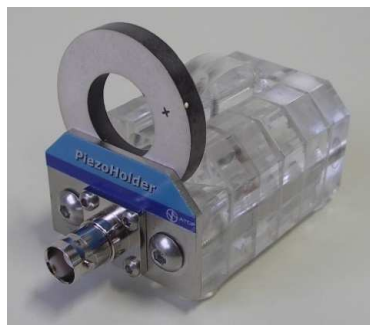
Insert the piezoelectric ceramic piece into the PiezoHolder (Figure 9). This accessory is capable of supporting ceramics shaped like disks and rings with thickness between 2 and 8 mm, and diameter between 20 and 60 mm. The polarity is not relevant.

Figure 9 – PiezoHolder support for the connection between ceramics and the TRZ Analyzer.

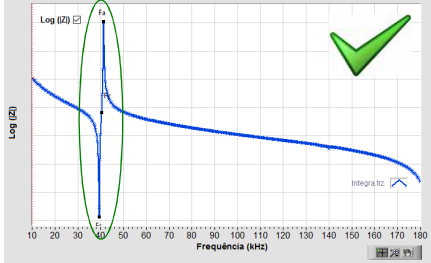
<p>This new ceramic was approved because there is no additional resonances and because of a well-defined main resonance. <i>Curiosity: the ATCP Physical Engineering logo was inspired by the shape of this wave pattern.</i></p>
<p>New ceramic with internal crack</p>

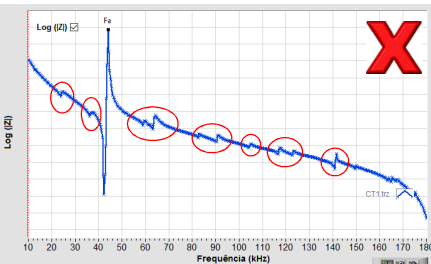
<p>This new ceramic was not approved because multiple additional resonances were detected. The existence of crack was confirmed by the non-destructive ultrasonic testing for the detection of discontinuities.</p>
<p>Used ceramic with internal crack</p>

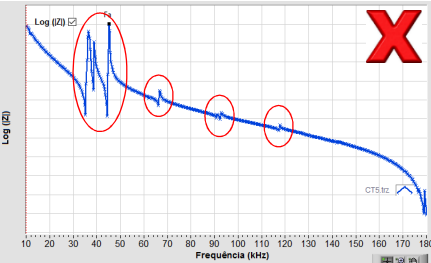
<p>This used ceramic was not approved because there are multiple additional resonances besides disturbances on the main resonance. The existence of crack was confirmed by the non-destructive ultrasonic testing for the detection of discontinuities.</p>
<p>New ceramic presenting a unknown defect</p>

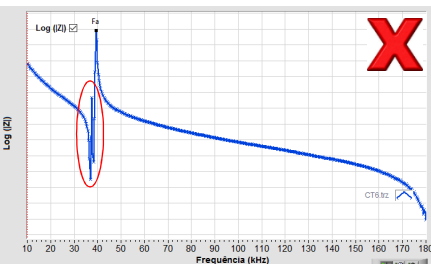
<p>This new ceramic was not approved because there is a disturbance on the main resonance, however it was not possible to confirm that it has an internal crack by non-destructive ultrasonic testing. The defect that generated this disturbance may be a density inhomogeneity of the pressed material.</p>

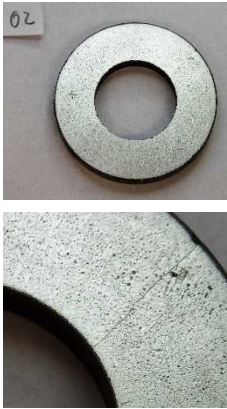
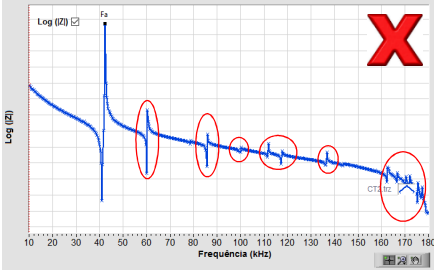
<p>This used ceramic was not approved because it shows a visible crack, besides multiple additional resonances.</p>
<p>Ruptured used ceramic missing a segment</p>

These cases present more accentuated additional resonances, but they are not too different from the additional resonances observed in internally cracked ceramics (refer to Table 1 curves).

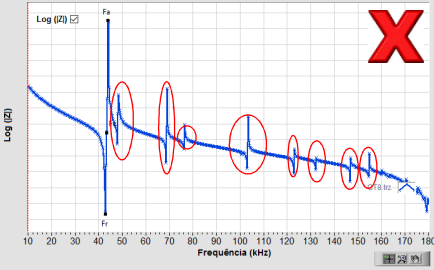
<p>The presentation of the test for this fractured ceramic missing a segment aims to illustrate the application of the methodology in an extreme condition.</p>

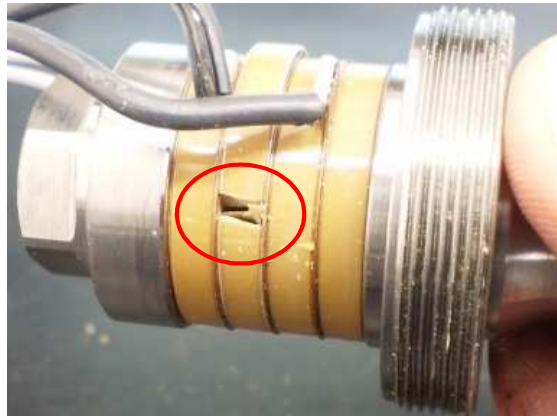
The fracture of ceramics is the main cause for faults of transducers and converters. Figure 11 exemplifies a 35 kHz damaged converter, highlighting the ruptured piezoelectric ceramic piece. However, not all ceramics of damaged transducers are necessarily compromised. On the contrary, some may be recovered to reduce maintenance costs, mainly when it comes to premature faults during manufacturing tests. For that, it is necessary to use a methodology that guarantees the inexistence of cracks in the ceramics that will be reused.

Figure 11 – Ultrasonic converter with a fractured piezoelectric ceramic piece. The other pieces were recovered and used after being tested for internal cracks.
